6 PRODUCT IMPROVEMENT TEST OF T53-L-11 ENGINE
IN THE UH-1D HELICOPTER.

9 Final Report of Test

11 5 Apr 1966

DEPARTMENT OF THE ARMY
UNITED STATES ARMY AVIATION TEST BOARD
Fort Rucker, Alabama 36360

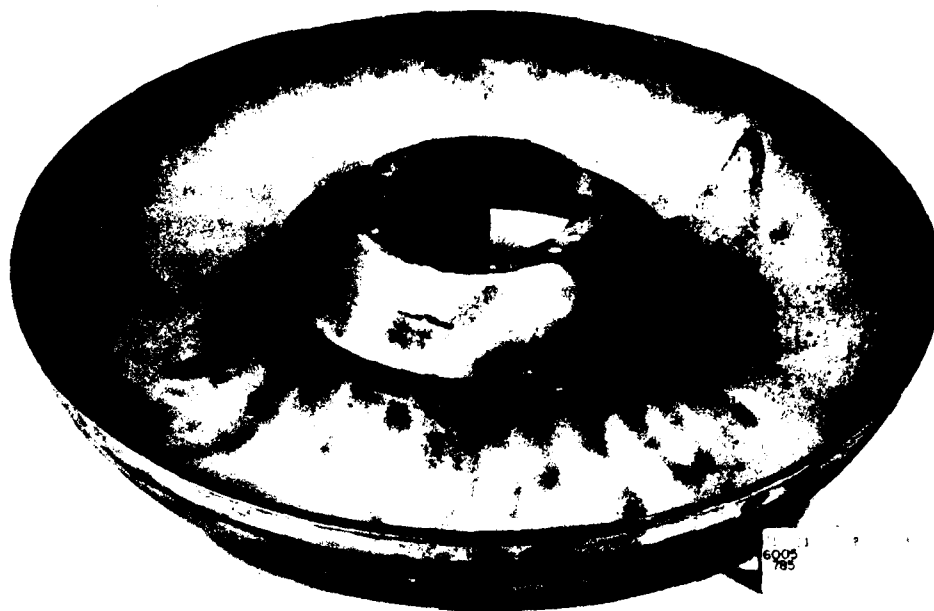
The combustor deflector was in serviceable condition at the termination of test (figure 1). No cracks were evident in the center seam weld. There were several small cracks in the spot weld area of the inner flange (figure 2).

Figure 1. Combustor deflector at the end of test.

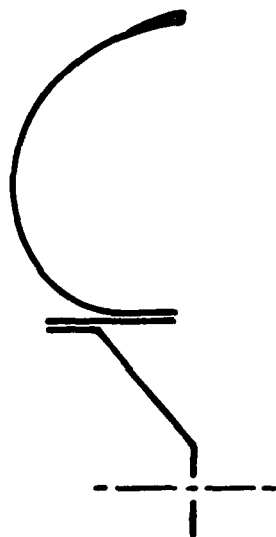
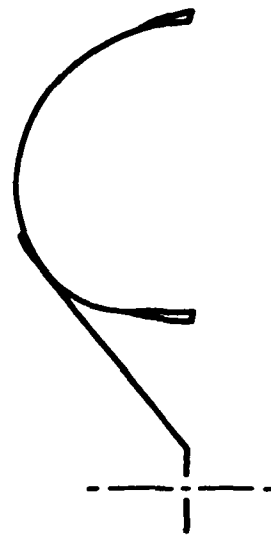
2.2.3.2.1. The combustor deflector is suitable and offers a definite improvement over the standard part (figure 3).

Figure 3. The design of the product-improvement combustor deflector (left) and of the standard combustor deflector (right).

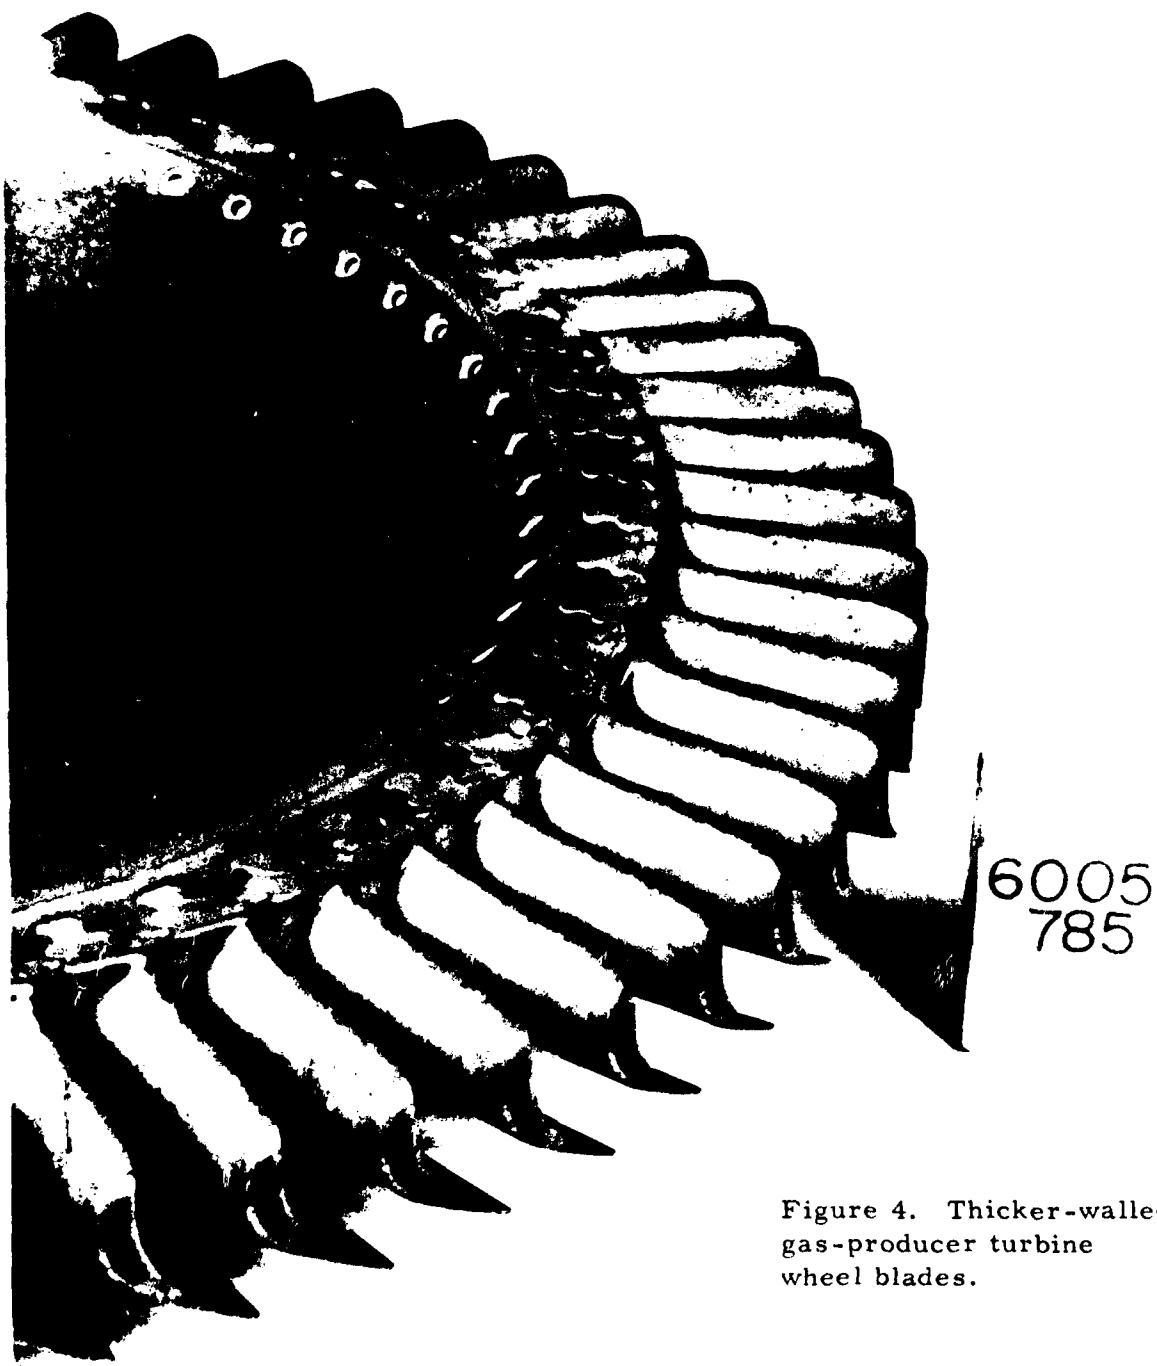
The gas-producer turbine wheel was in serviceable condition at the termination of test. Zyglo inspection revealed no cracks. The blades had experienced erosion (figure 4), but they met the serviceability criteria for erosion contained in Technical Manual 55-152-211-35 (reference 10, appendix I).

2.2.4.2.2. The thicker-walled blades have alleviated the cracking problem. The erosion was due to a combination of sand ingestion and combustion products.

Figure 4. Thicker-walled
gas-producer turbine
wheel blades.

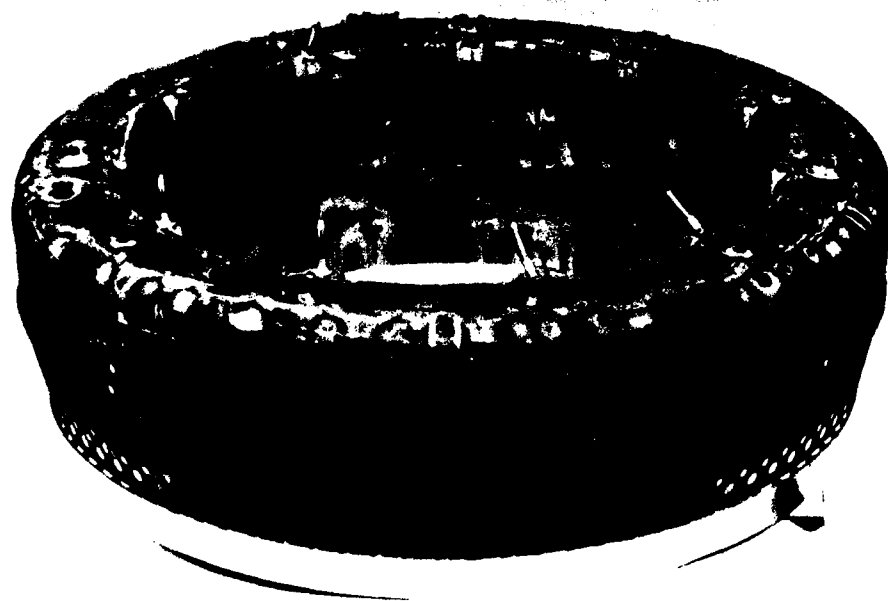
2.2.5.1.1. No bracket failures were observed during the test. It was discovered at final disassembly that the bracket in position 8 was broken (figures 5 and 6).

Figure 5. Combustor liner mounting system.

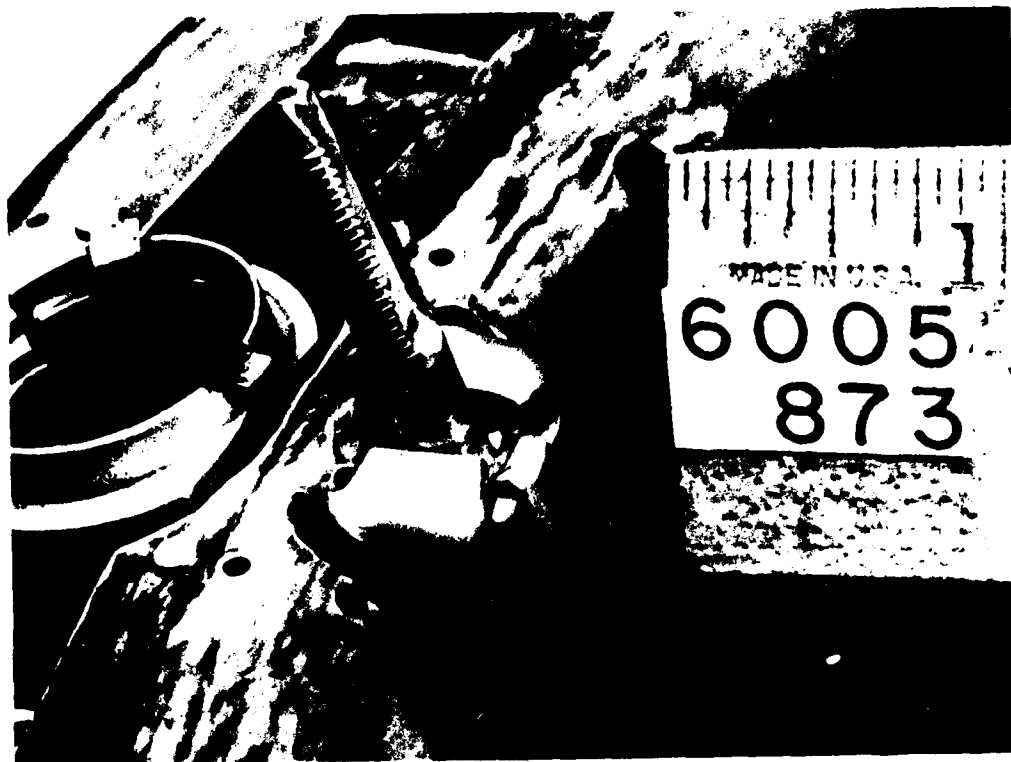
2.2.5.1.2. At disassembly, the solid suspension studs (without bushings) were in positions 2, 5, and 8. (The correct mounting positions are 1, 5, and 8.) A solid suspension stud is shown in figure 7 and a flexible mount stud in figure 8.

Figure 7. Solid suspension stud.

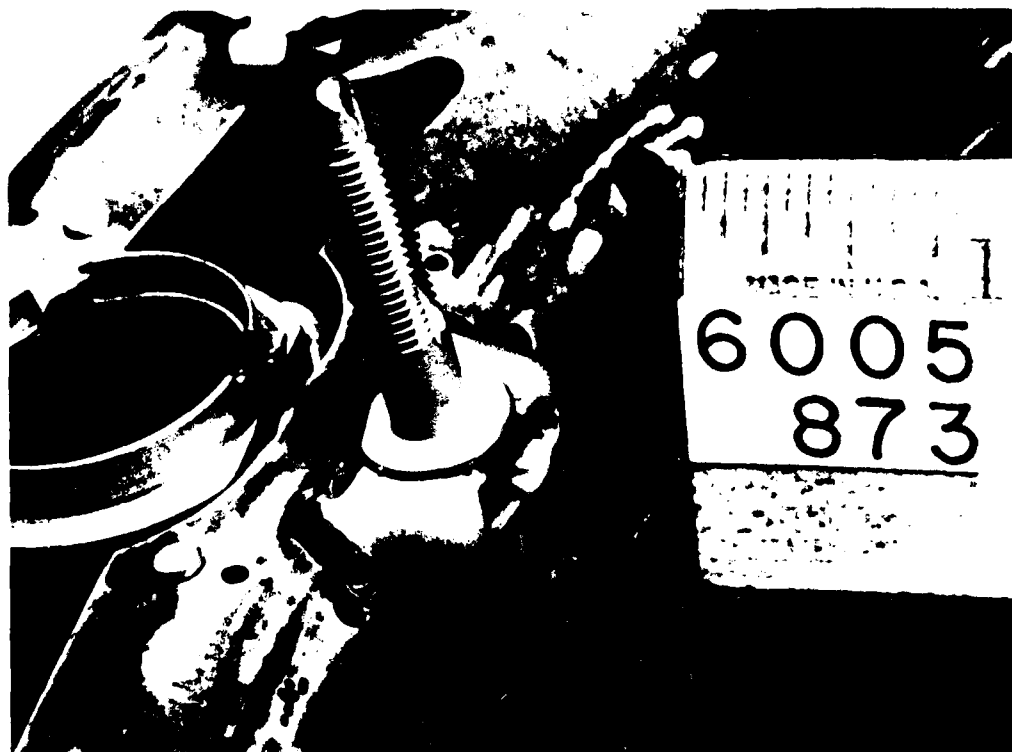
Figure 8. Flexible mount stud.

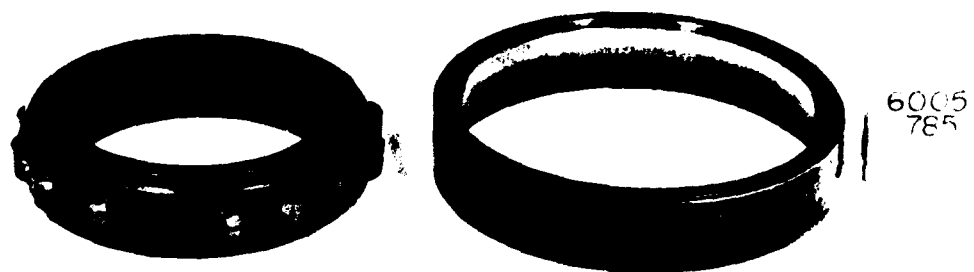
2.2.7.1.1. The original No. 2 bearing was lost as a test item after 533 hours because of the replacement of the compressor section. The bearing installed as a portion of the new compressor attained 358 hours during the remainder of the test. No cage deterioration was evident, and the bearing rolls and races were in good condition (figure 10).

Figure 10. No. 2 bearing rolls and races.

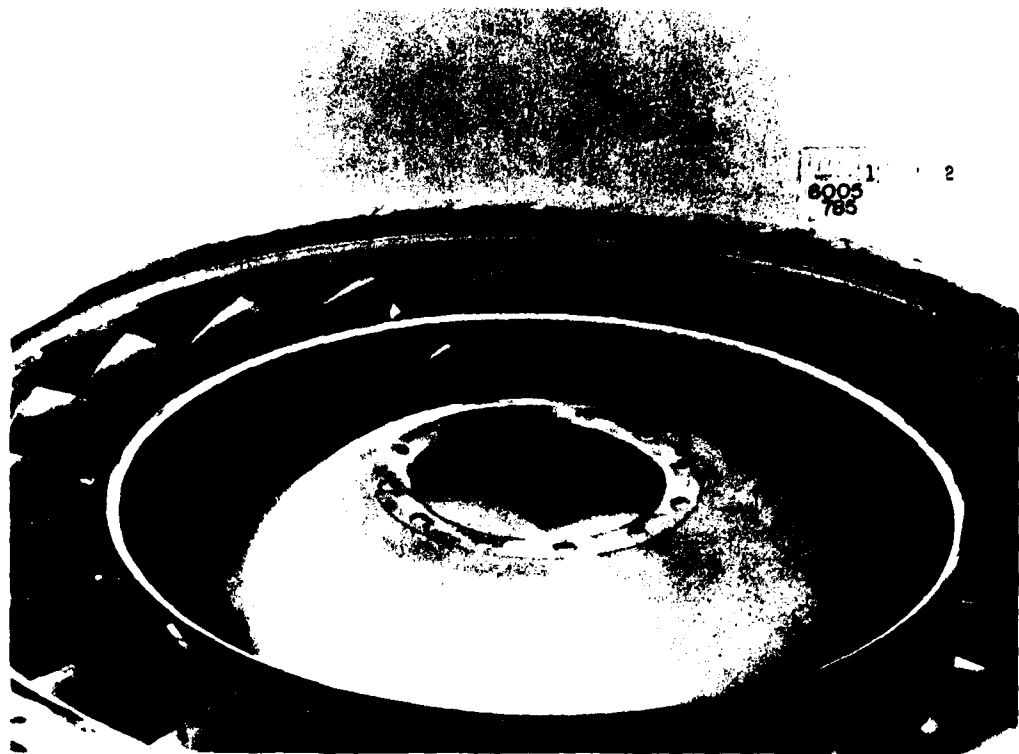
Figure 14. Damage sustained by the power turbine nozzle when the No. 4 bearing failed.

The nozzle was operated throughout the test. Because of the bearing failure, it was scuffed heavily by the power turbine (figure 14)

and was no longer serviceable. The nozzle was cracked in the outer-shroud vane brazements (figure 15). No cracks were evident on the inner shroud.

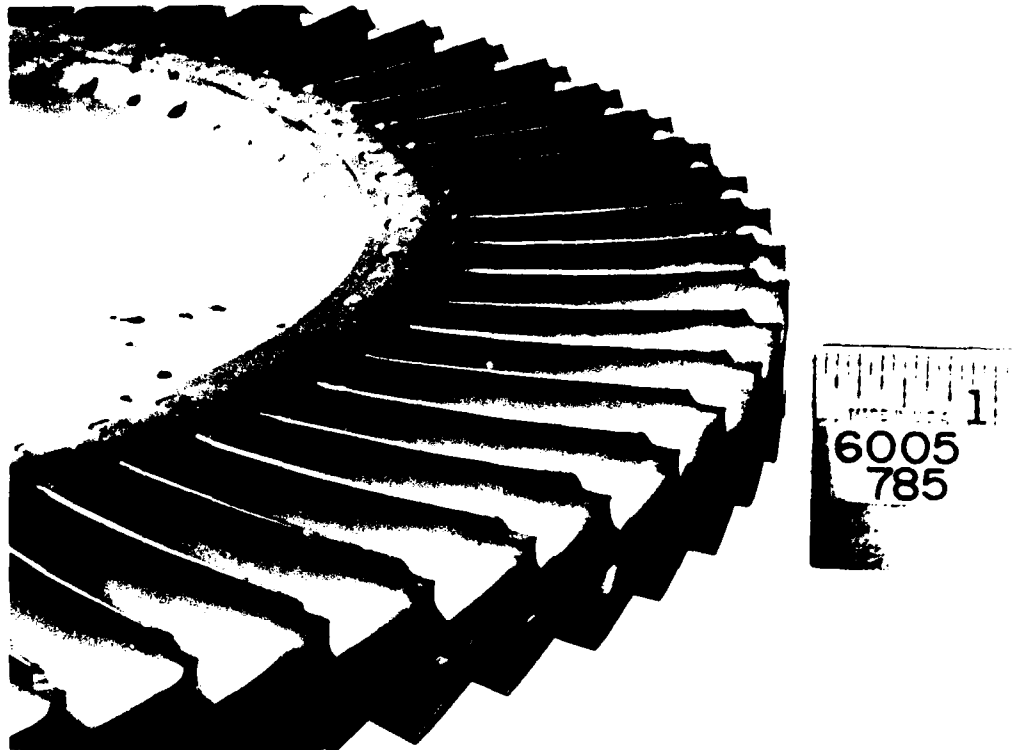
Figure 16. Damage sustained by the power turbine wheel when the No. 4 bearing failed.

The power turbine wheel was operated throughout the test. When the wheel moved forward during the bearing failure and contacted the power turbine nozzle, heavy scuffs were incurred at the disc face and the blade leading edges on the outer diameter (figure 16).

Tip clearance* data were not valid because of the heavy scuffing incurred when the bearing failed. Therefore, suitability cannot be determined.

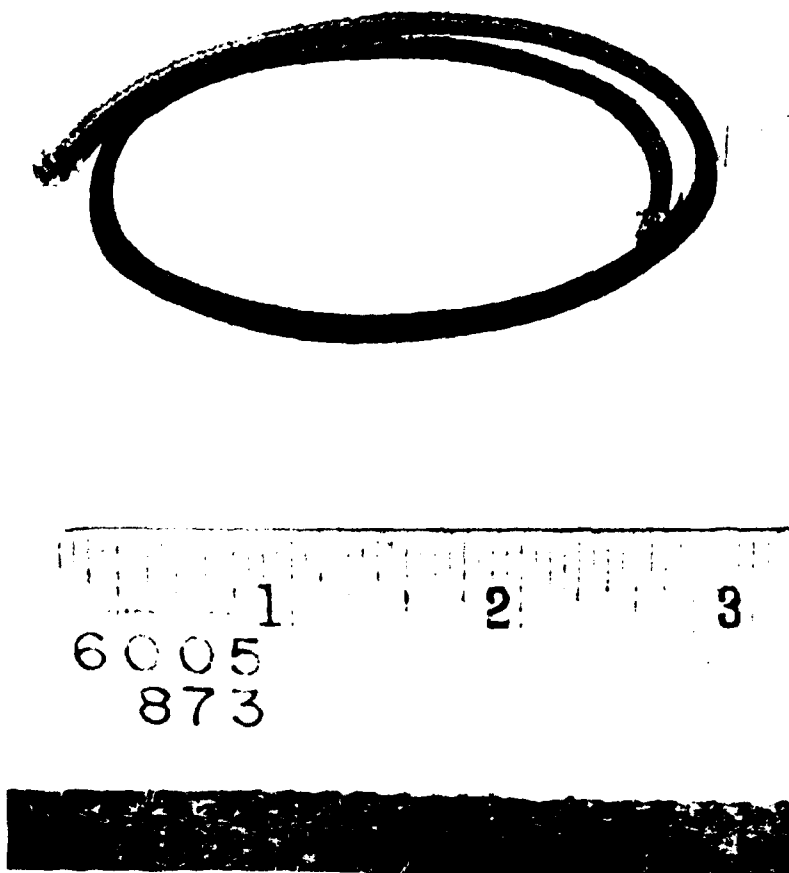
Figure 17. Asbestos air seal at the end of test.

The seal was in serviceable condition at the termination of the test (figure 17).
